Limited Phase II Environmental Site Assessment

Bell Trading Post Property

Albuquerque, Bernalillo County, New Mexico

June 30, 2014

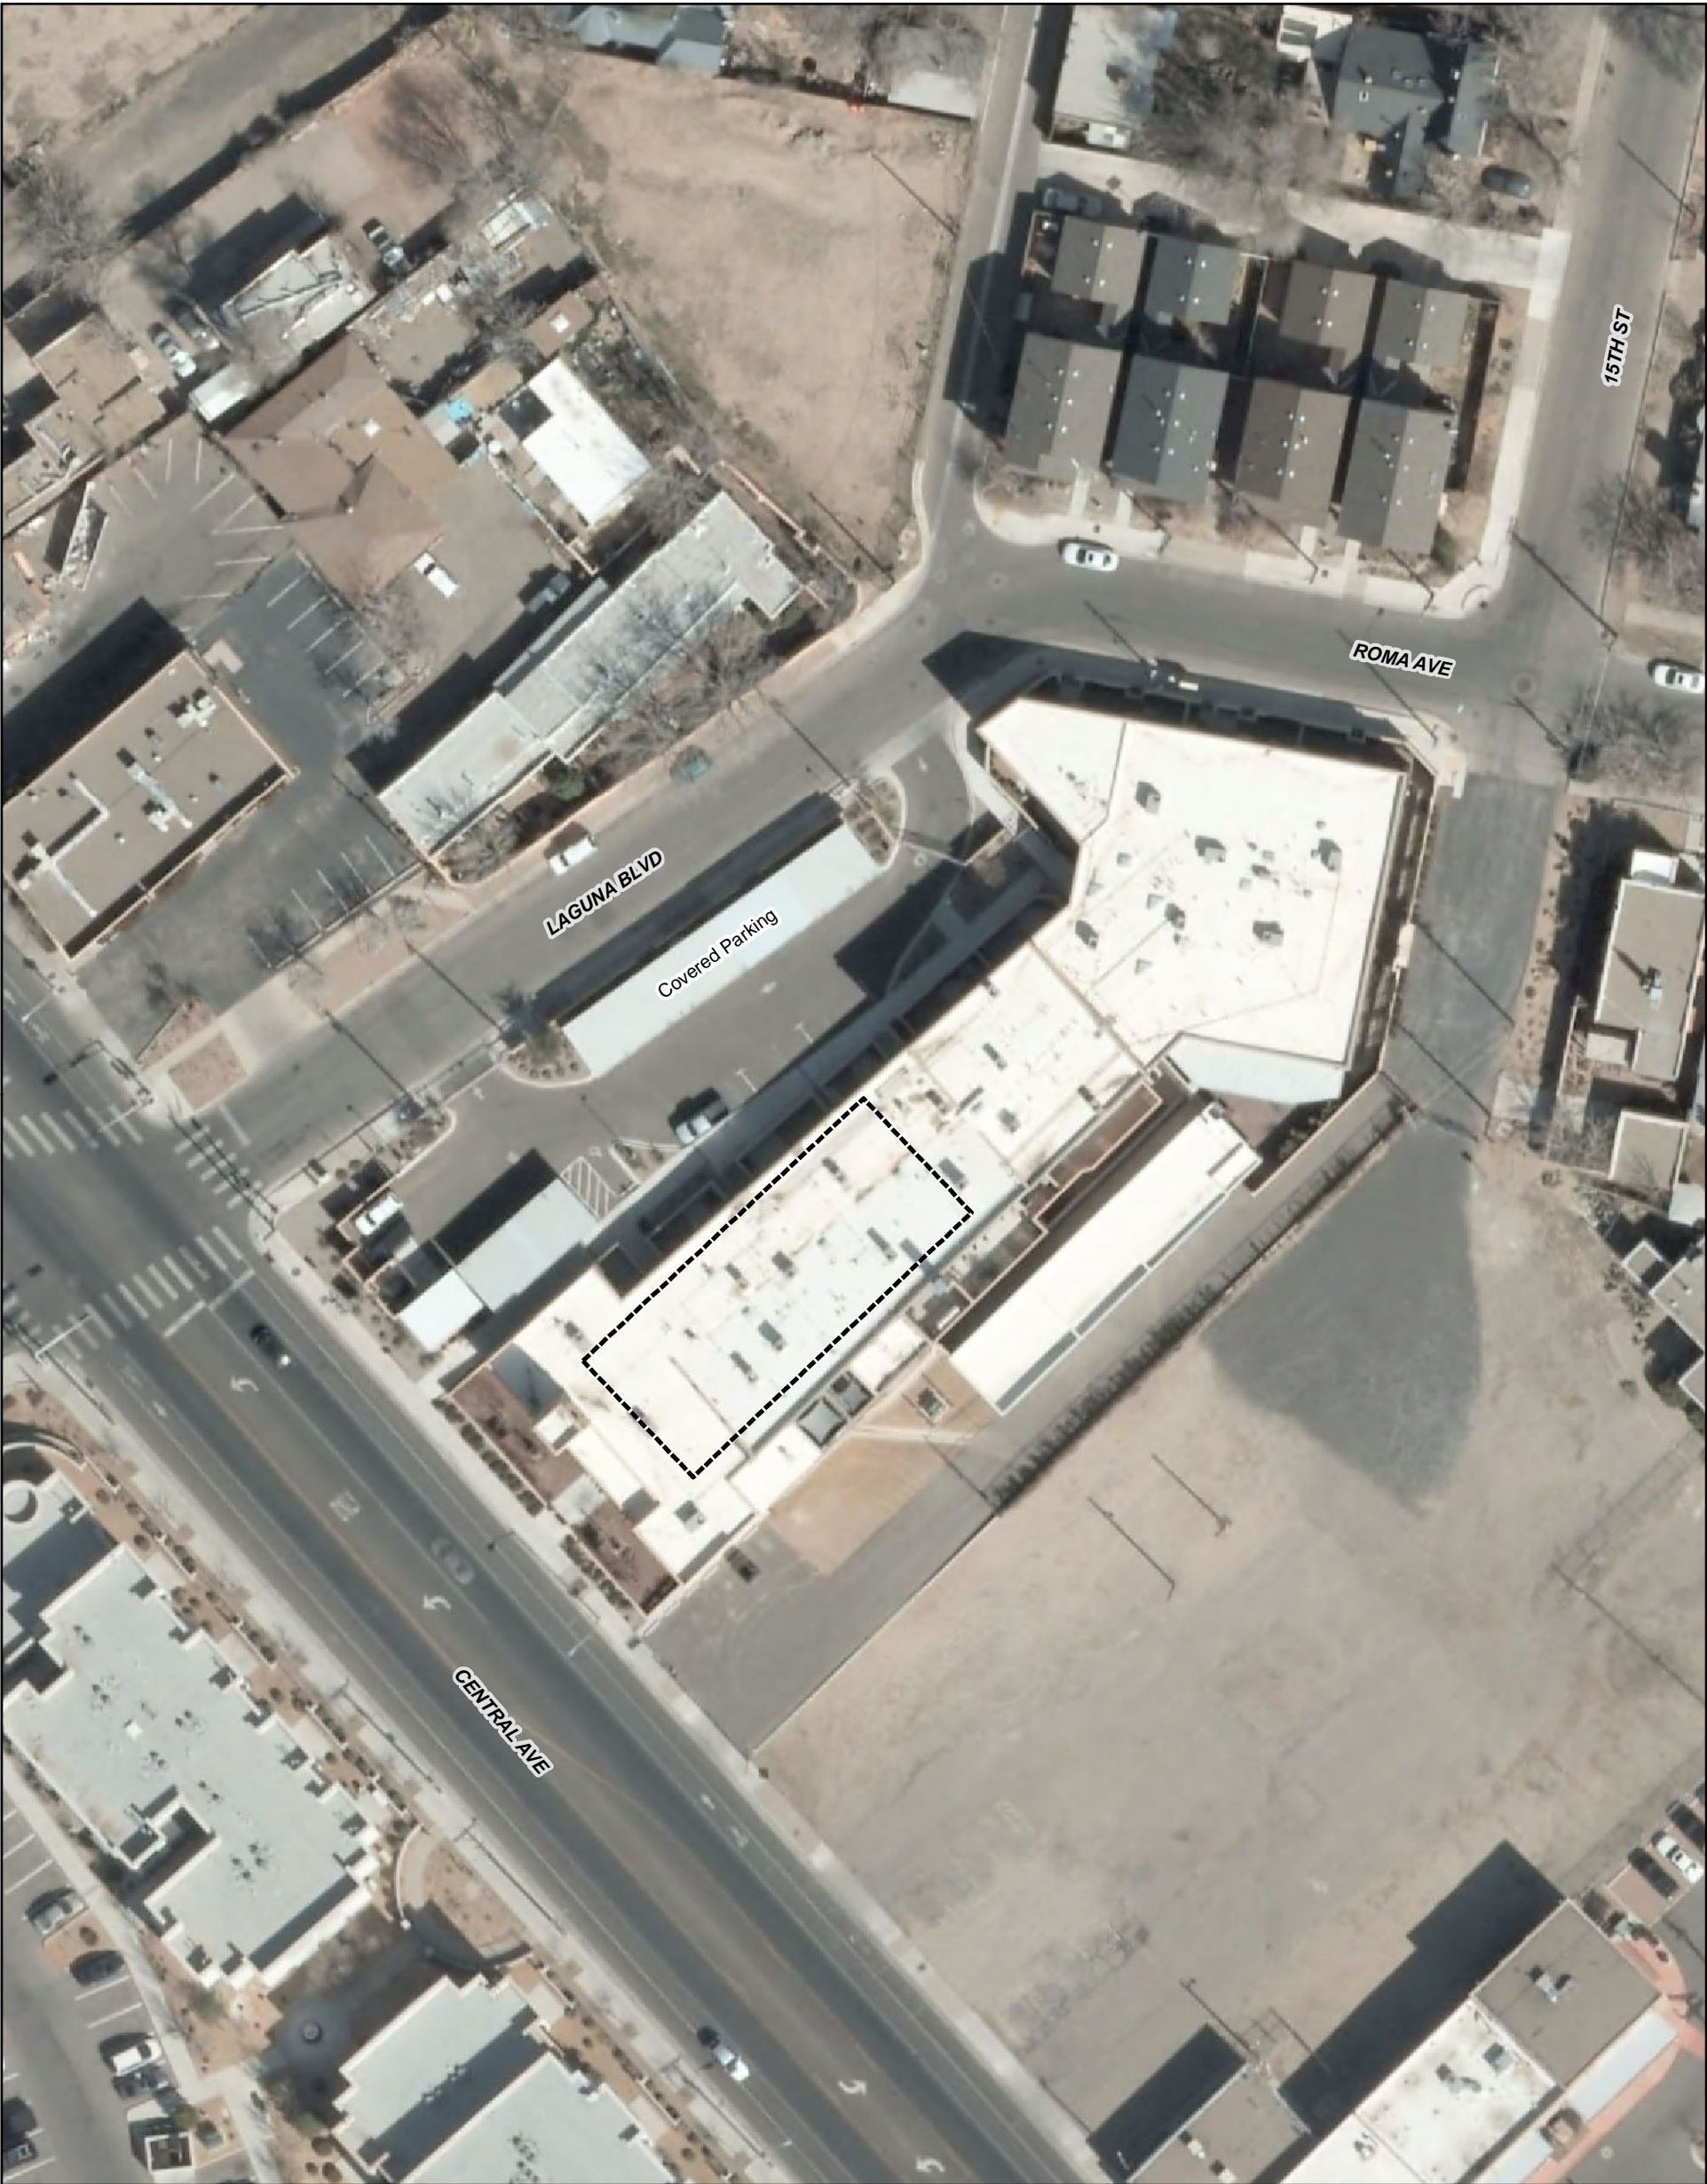
Figure 2
Site Map
Former Bell Trading Post Property,
Albuquerque, New Mexico

Located at 1503 Central Avenue Northwest in Albuquerque, New Mexico, the Site occurs within a mixed use commercial residential area of the City of Albuquerque (City) and is bounded to the southwest by Central Ave SW, northwest by Laguna Blvd NW, north by Roma Ave NW, and east by the termination of 15th St NW to the south (Figure 1 and 2).

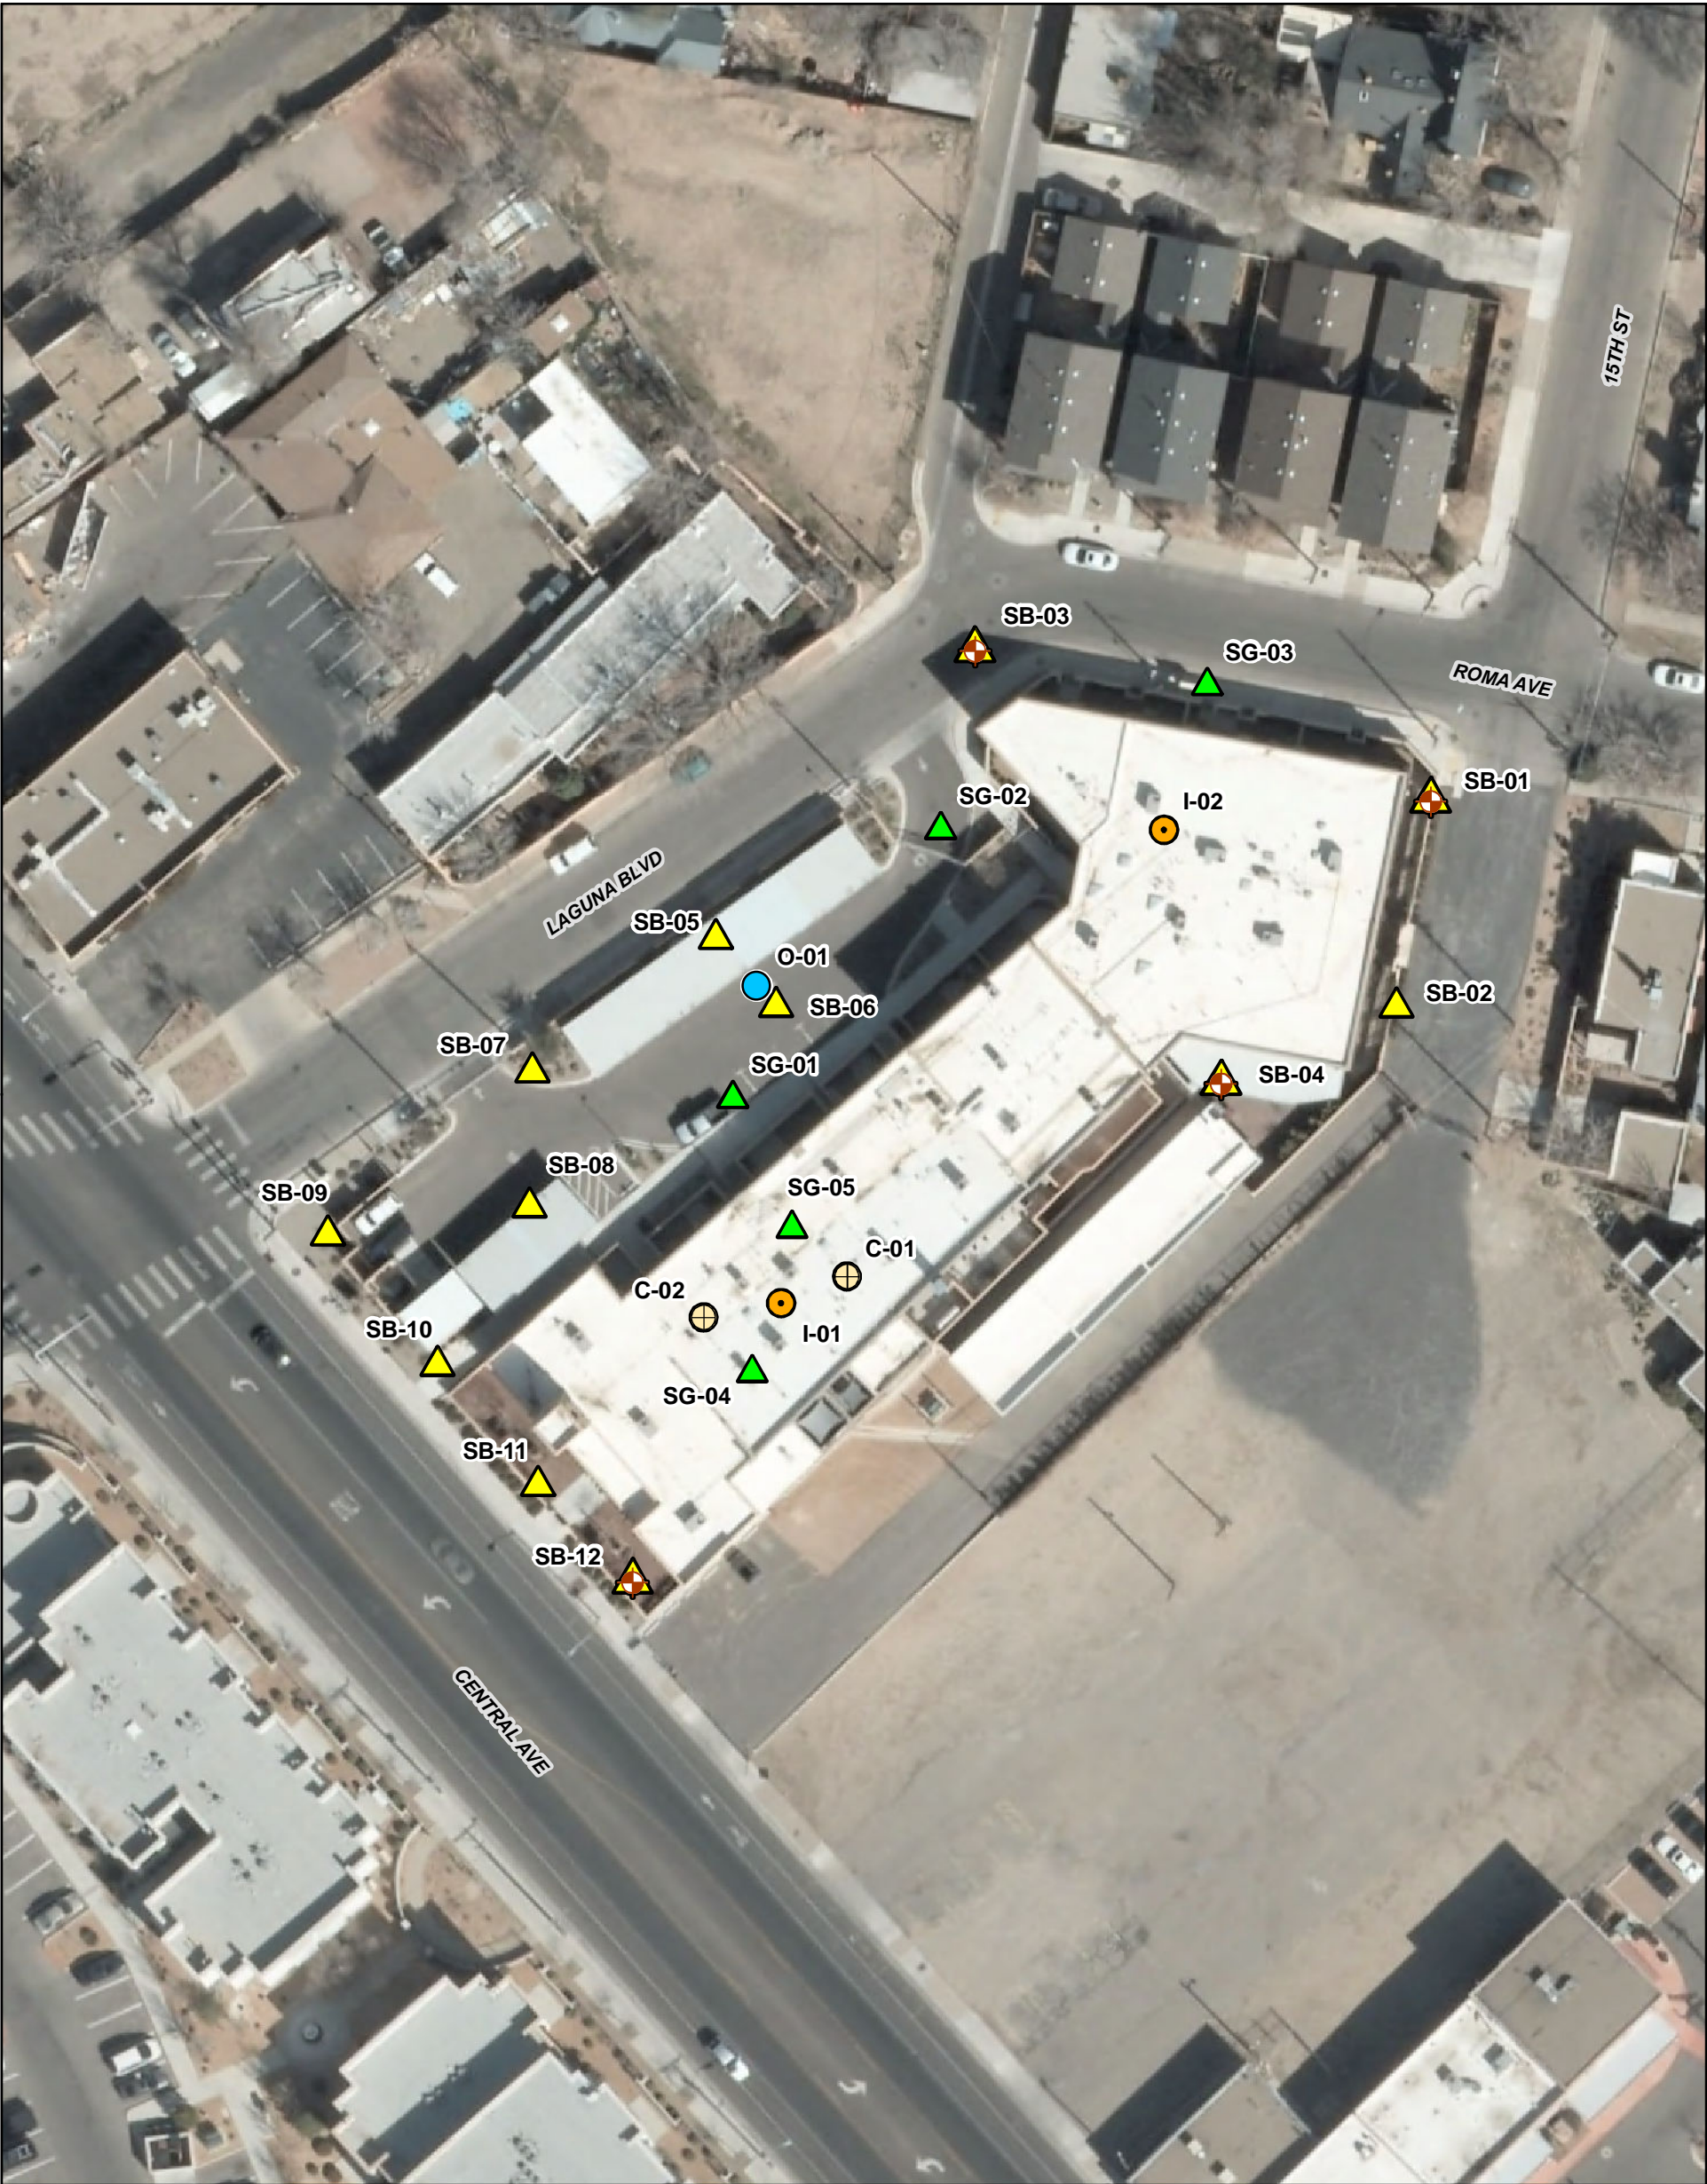
Figure 3
Soil Gas and Air Sampling Locations
Former Bell Trading Post Property,
Albuquerque, New Mexico

A total of four (4) soil gas vapor grab samples (sample IDs: SG-04-249477, SG-04-249478, SG-05-247808, SG-05-249476) were collected from two locations (SG-04 and SG-05) within the crawlspace of the Site Building (Figure 3). The two soil borings were advanced below the dirt floor of the crawlspace to a TD of approximately 2 ft bgs. Although, the original target TD for these samples was approximately 1 ft bgs, a decision was made to advance an extra foot due to the relatively loose soils within the Site building crawlspace to try and ensure extraction of subsurface soil vapor only. The crawlspace dehumidifier was also turned off prior to and during the crawlspace sample collection efforts to help ensure minimal draw and prevent possible dilution of the soil vapor samples.

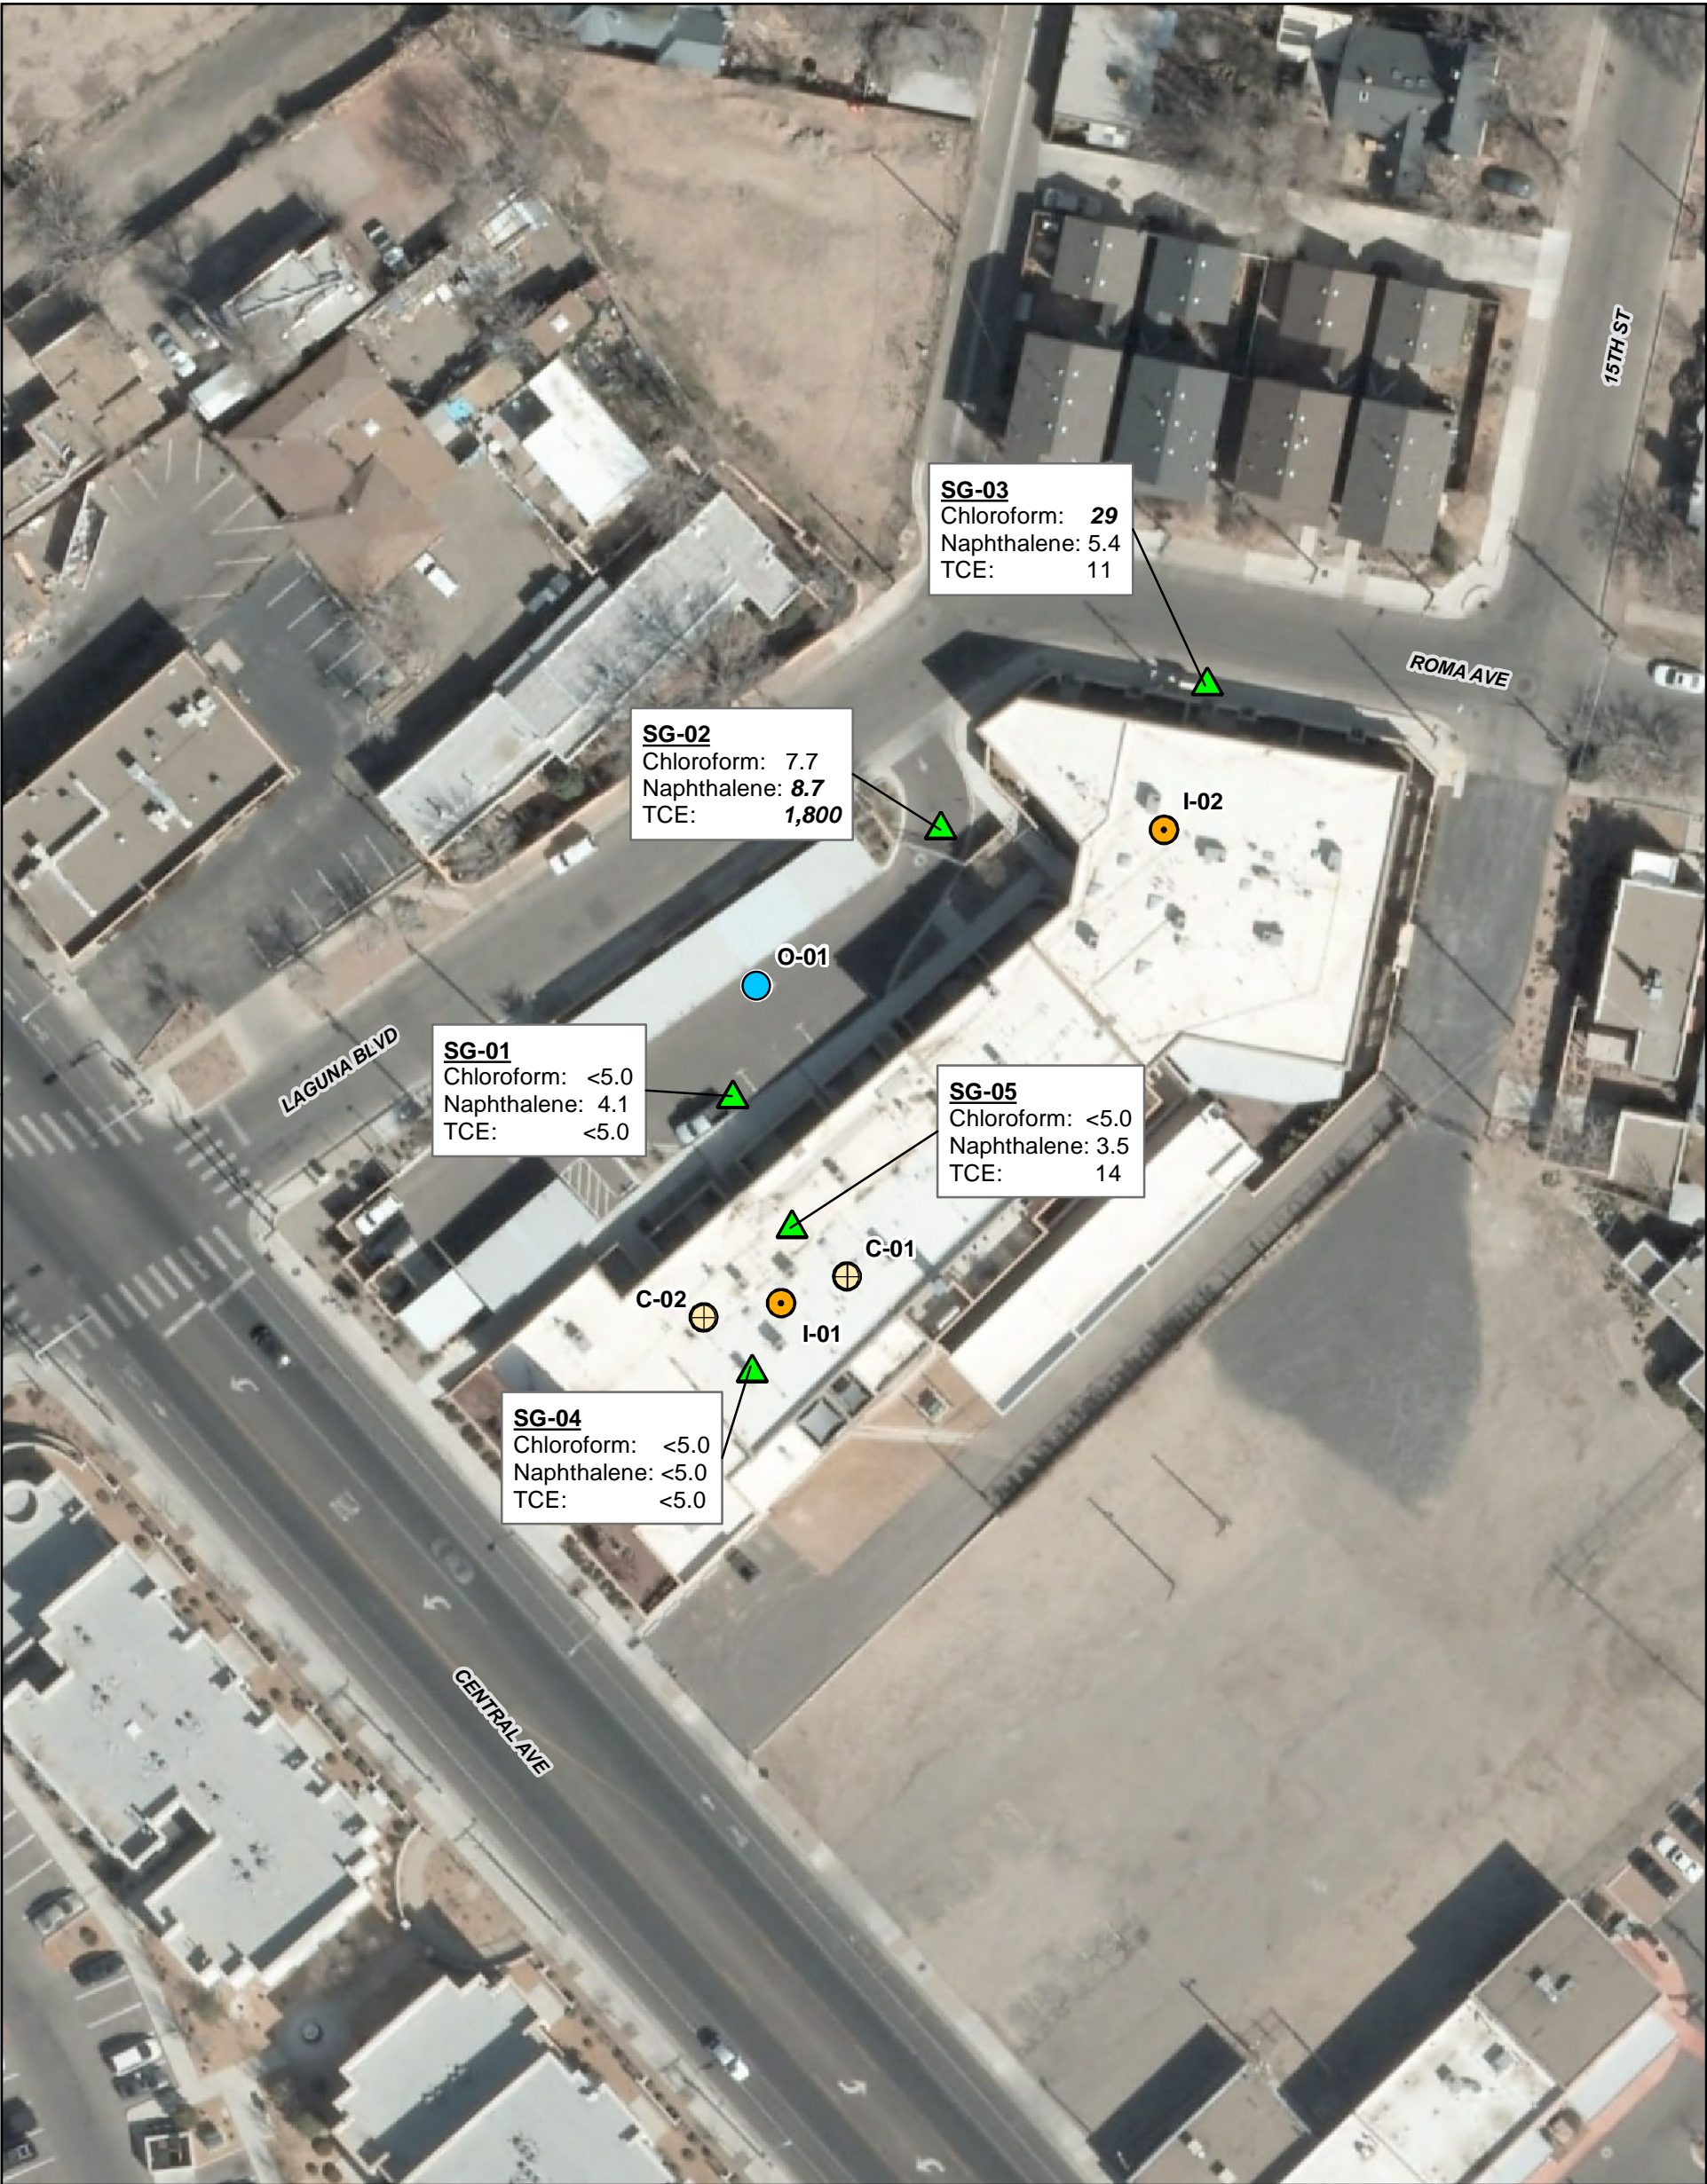
Figure 4
VOC Concentrations in Soil Gas
Former Bell Trading Post Property,
Albuquerque, New Mexico

In Site soil vapor, 26 out of the 71 VOCs analyzed were found to be present in one or more samples at concentrations above RLs. Of these COPCs, chloroform, naphthalene, and TCE were present in one or more samples at concentrations in excess of EPA VISLs (Table 2, Figure 4). All three of these VOCs were identified in soil vapor collected from locations SG-02 and SG-03 situated along on the north/west perimeter of the building. Chloroform was reported at a concentration of $7.7 \mu\text{g}/\text{m}^3$ at SG-02 and $29 \mu\text{g}/\text{m}^3$ at SG-03. The corresponding EPA VISL for chloroform in sub-slab/exterior conditions (adjusted for a total target cancer risk of 10^{-5}) is $12 \mu\text{g}/\text{m}^3$. Chloroform was not identified in soil vapor above RLs at any other locations.

Naphthalene was present in soil vapor at all locations except SG-04. At locations SG-02 and SG-03 naphthalene was reported at concentrations of $8.7 \mu\text{g}/\text{m}^3$ and $5.4 \mu\text{g}/\text{m}^3$, respectively: the corresponding EPA VISL for naphthalene in sub-slab/exterior conditions (adjusted for a total target cancer risk of 10^{-5}) is $8.3 \mu\text{g}/\text{m}^3$. Naphthalene was also reported at Location SG-01 and SG-05 but at trace concentration (at or below the quantitation limit [RL]).

TCE was reported in soil vapor at SG-02 at a minimum concentration of $1,800 \mu\text{g}/\text{m}^3$. Exact quantitation of TCE at this location could not be evaluated due to limitation of the analytical method's maximum quantitation limit/method detection limit (MDL) (Appendix D). This reported concentration far exceeds the recommended EPA VISL for TCE of $21 \mu\text{g}/\text{m}^3$. TCE was also reported in soil vapor at locations SG-03 and SG-05 but the reported TCE concentrations at these locations were significantly less ($11 \mu\text{g}/\text{m}^3$ and $14 \mu\text{g}/\text{m}^3$, respectively) and below recommended screening levels.

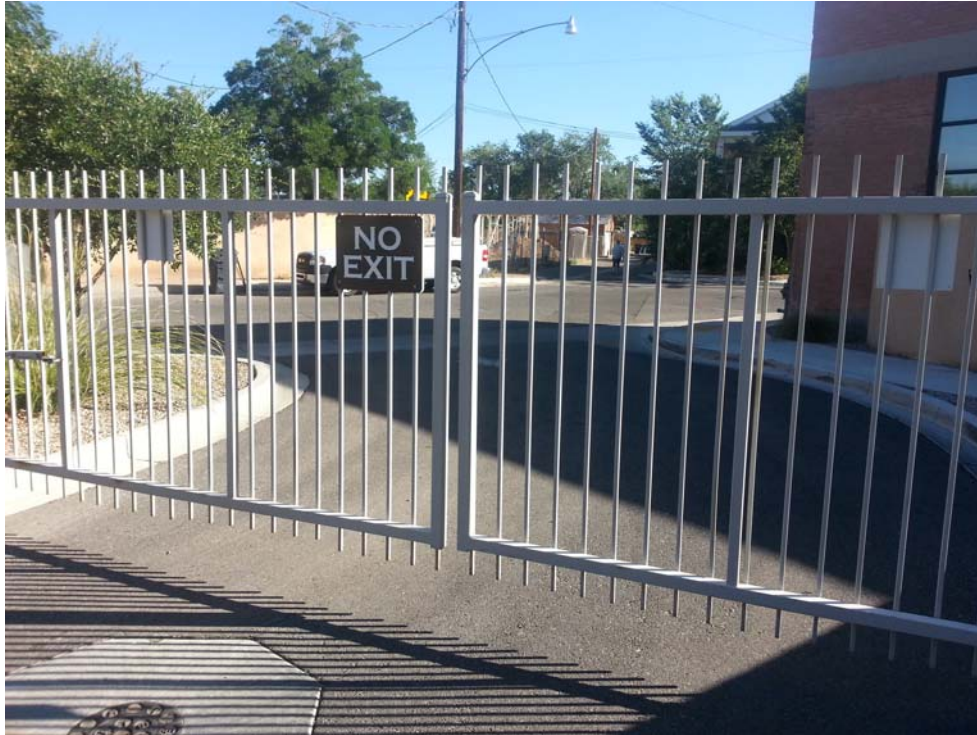
Photo 1: View of the Site's northwest entrance from inside gated parking lot, facing north towards Laguna Blvd and Roma Ave intersection.

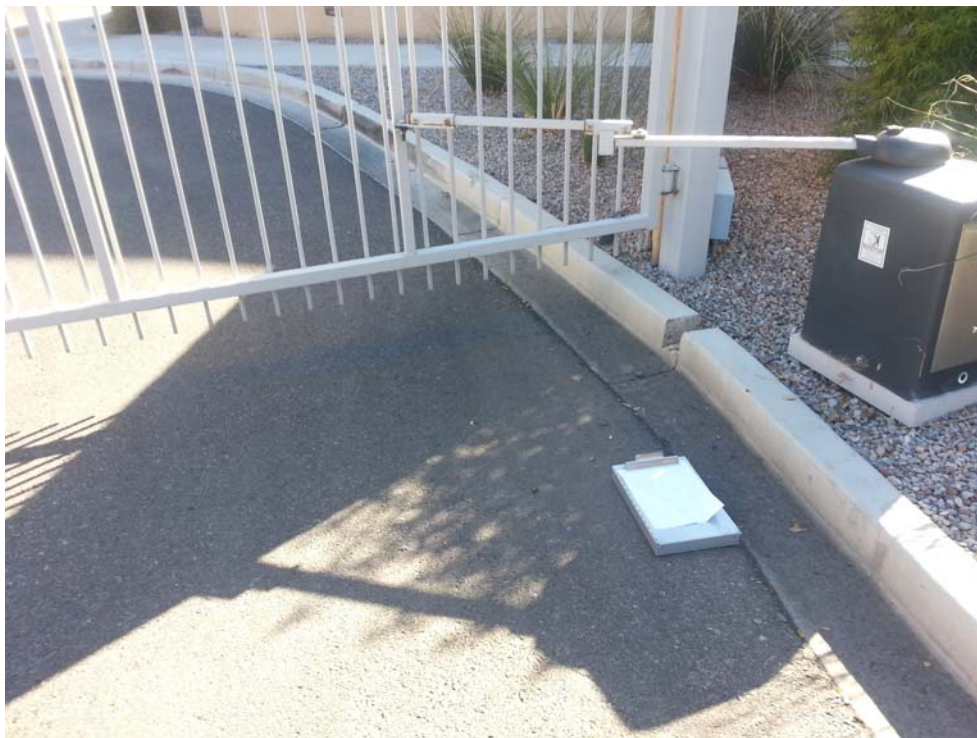
Photo 2: Proposed soil gas sampling location SG-02. Location SG-02 was bored approximately 4 ft from the gate on the opposite side, approximately 1 ft from the curb.

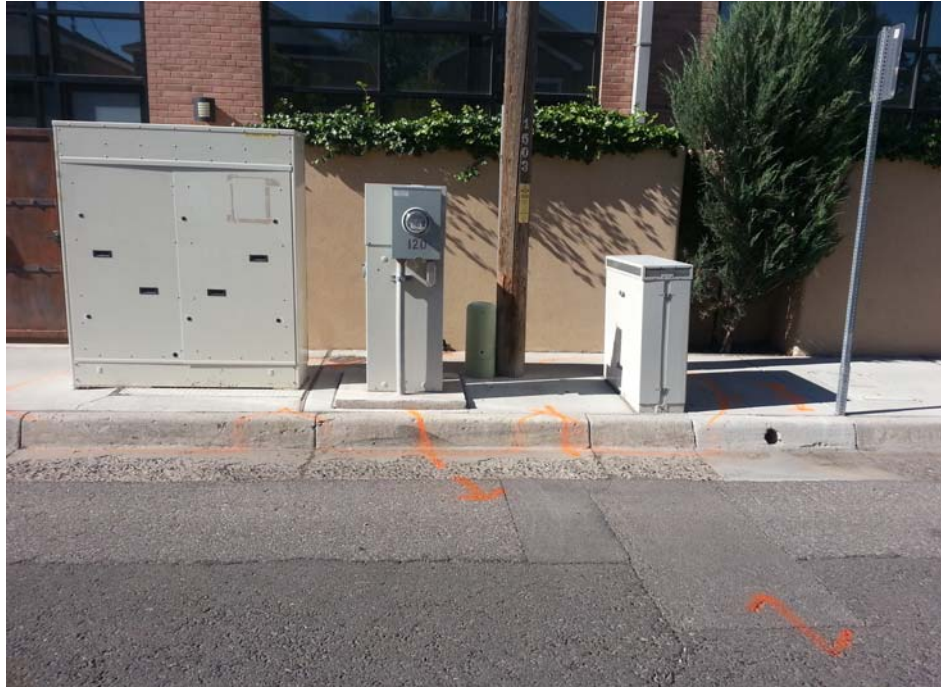
Photo 3: Proposed soil gas sampling location SG-03. The presence of telecommunication lines required Location SG-03 to be adjusted slightly to the east (left in picture).

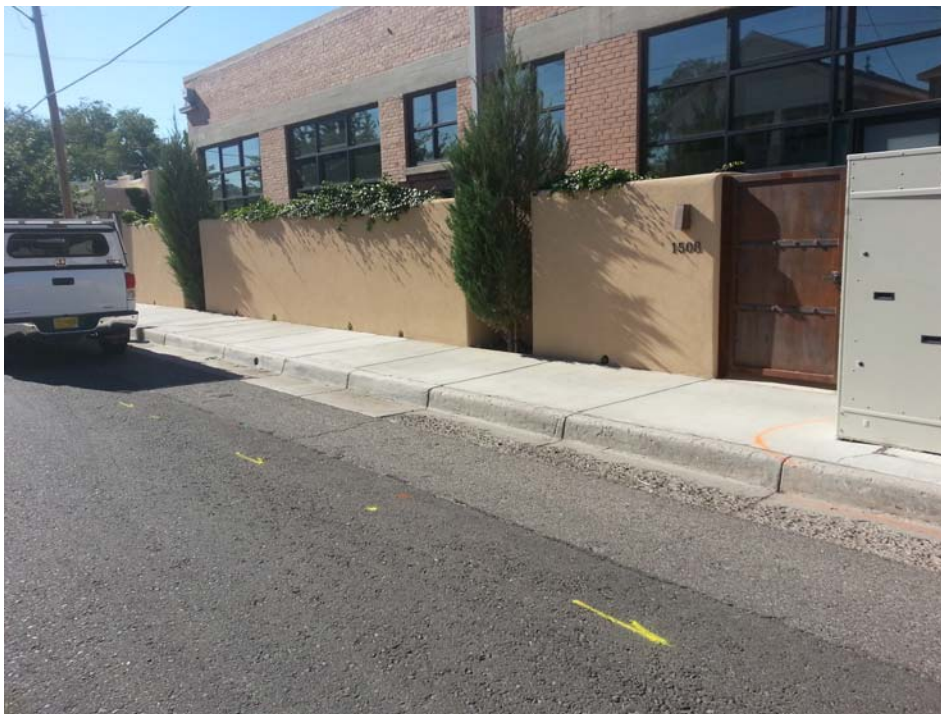
Photo 4: Proposed soil gas sampling location SG-03, just east of telecommunication lines. Location SG-03 was drilled through the sidewalk, approximately 1 ft from the evergreen tree pictured in the center.

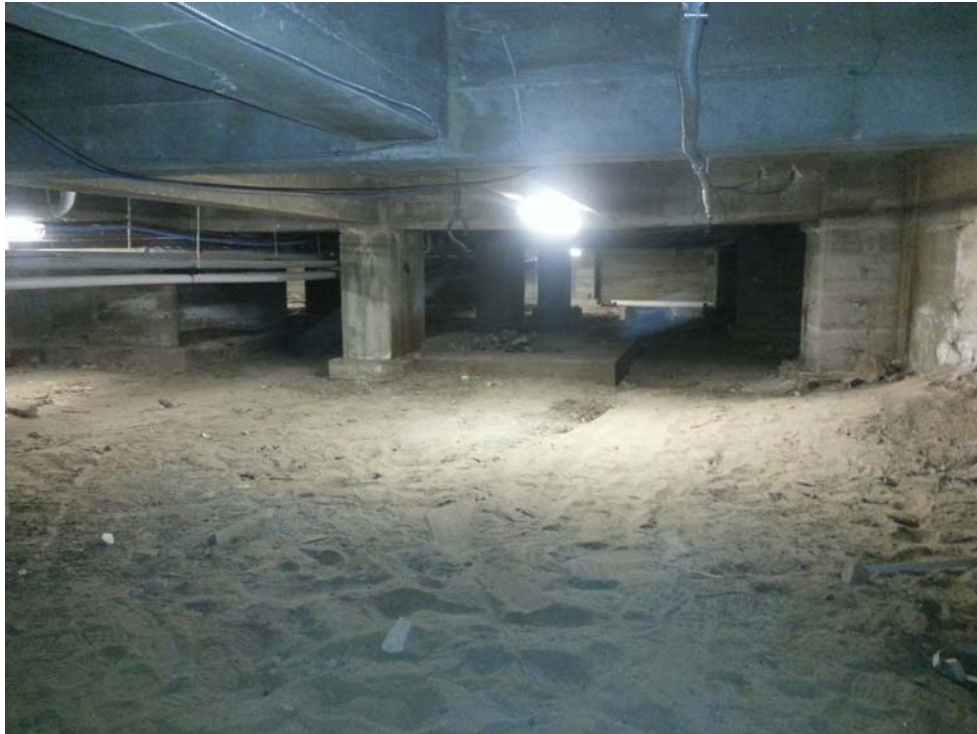
Photo 5: Site Building Crawlspace.

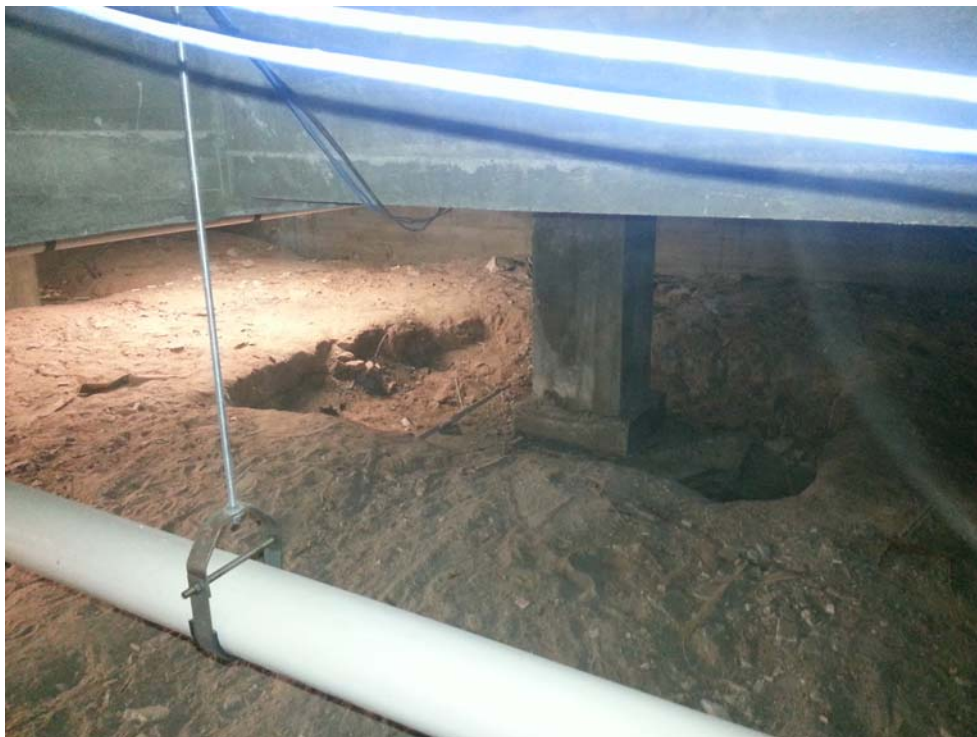
Photo 6: Site Building Crawlspace. Note small excavation area around one of the crawlspace piers, exposing unconsolidated material to approximately 1.5 ft deep.

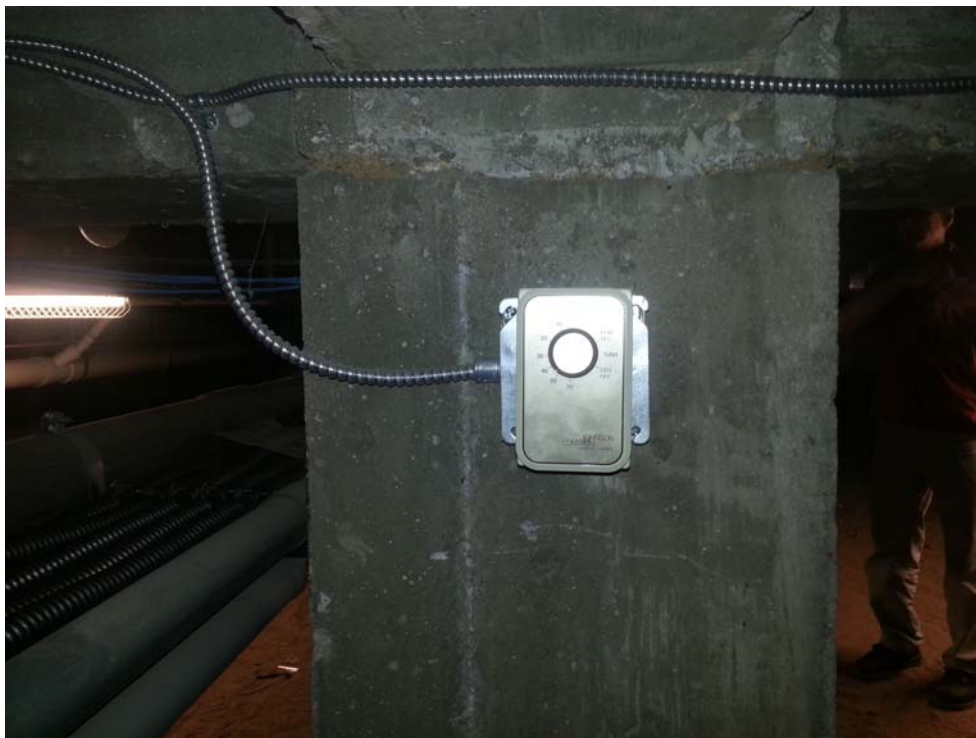
Photo 7: Operational humistat installed to control crawlspace air flow and humidity within the Site Building crawlspace. Typically, humidity levels were set at 45%. Note: System was turned off for the duration execution of air sampling.

Maintaining the VOC concentrations below levels of concern is likely dependent on continued operation of a well-ventilated Site building crawlspace. The levels of VOCs present in indoor air may also be impacted by changes in the barometric pressure which can have a seasonal fluidity. For example, changes in humidity, the use of heating/cooling systems within the building, and variable water use outside the building can all impact the rate at which soil gas migrates upward within the subsurface.

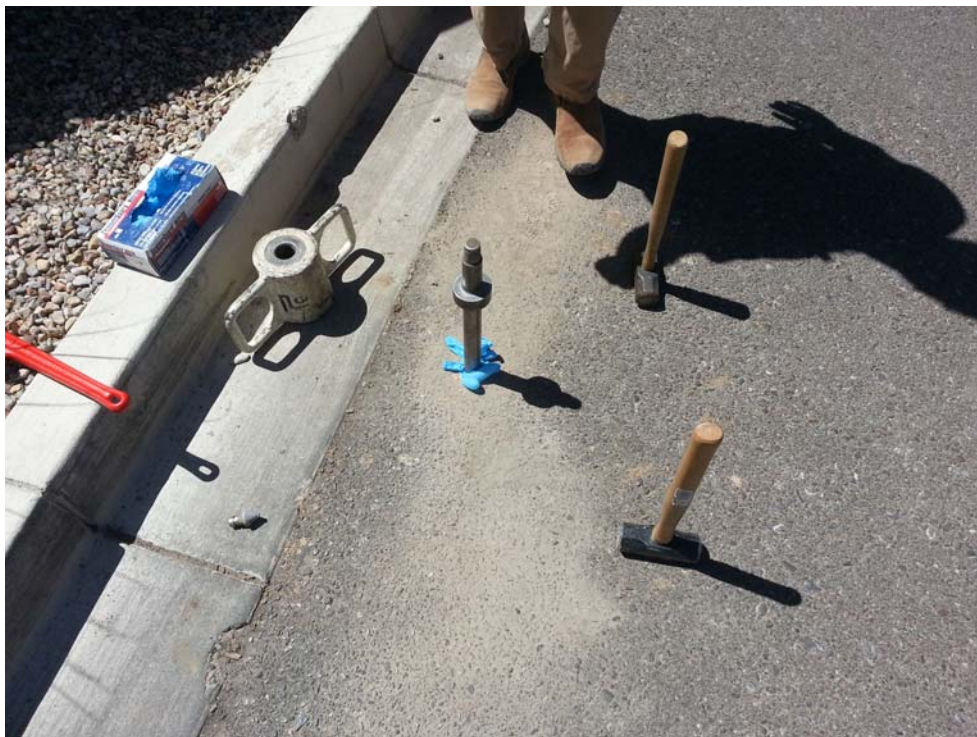
Photo 10: Soil gas sampling at Location SG-02. Annular space sealed with inflated nitrile gloves to help ensure airtight seal between subsurface and drill pipe was maintained during vapor extraction.
